Property Inspection Report
performed by

Ellis Co. Home Inspections

for
123 USA St.
Somewhere in Ellis County, TX

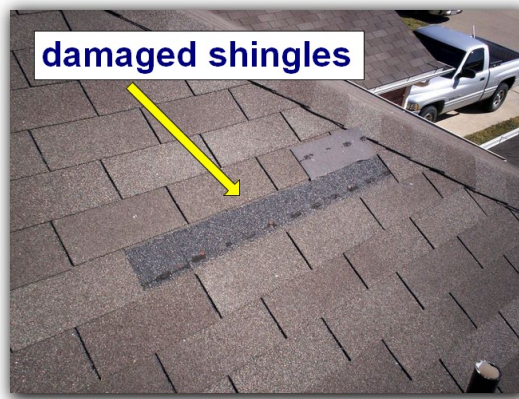
There were a few damaged shingles on the roof. (see photo for example)

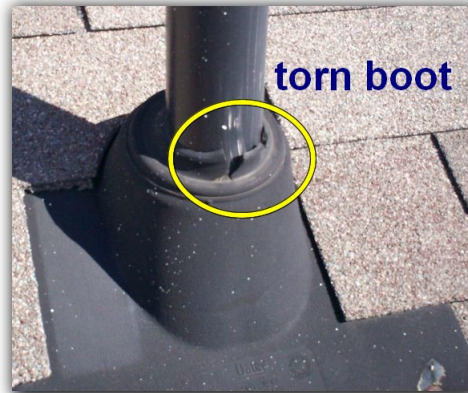
There was one rubber bootjack (over a plumbing vent) that was split or torn. (see photo) This issue may allow water entry.

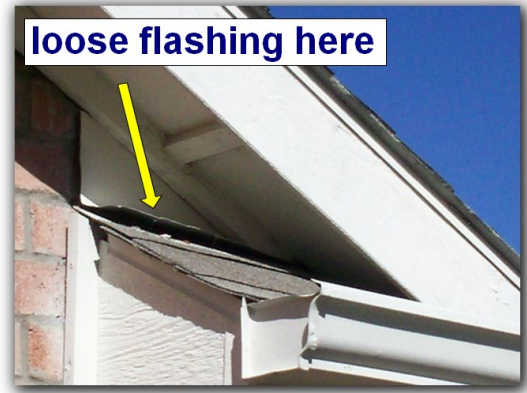
At the front of the house, there was a loose flashing just above the eaves. (see photo above right)

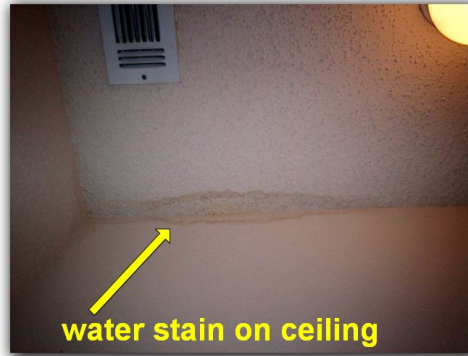
There was a stain on the ceiling of the master bathroom that may indicate a leak from above this area. (see photo) *Note - It is recommended to monitor water stains after heavy rains. If leaks are still present, make repairs as required.*

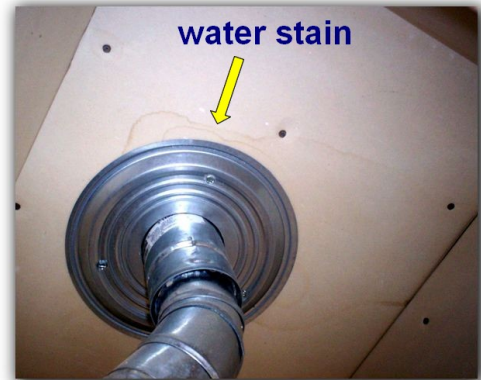
There was a stain on the ceiling above the water heater that may indicate a leak from above this area. (see photo above right) *Note - It is recommended to monitor water stains after heavy rains. If leaks are still present, make repairs as required.*

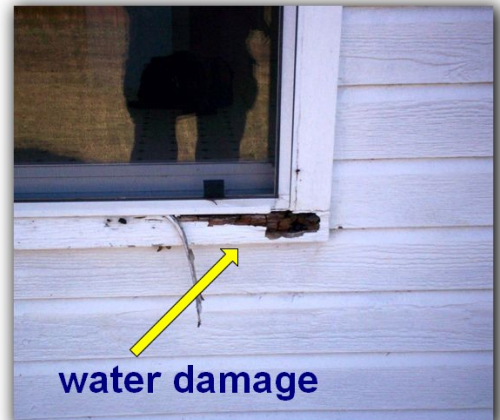
From outside, there were a few small splits or openings noticed in the caulking around several of the windows. (Between the brick and window frame) These areas should be caulked or otherwise sealed to prevent water entry. (see photo for one example)

At the back of the house, there were some windows with water damaged trim. (see photo above)

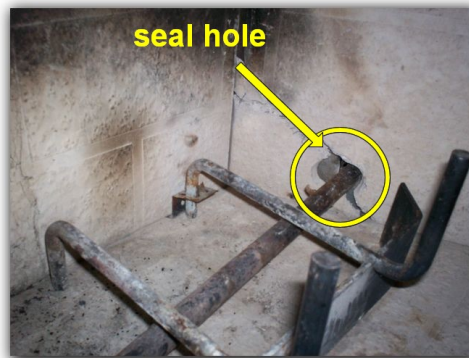
Potential Safety Issue - Inside the firebox, no sealant was present around the gas pipe entry. (see photo) The gap around this pipe should be sealed with an approved firebox rated sealant.

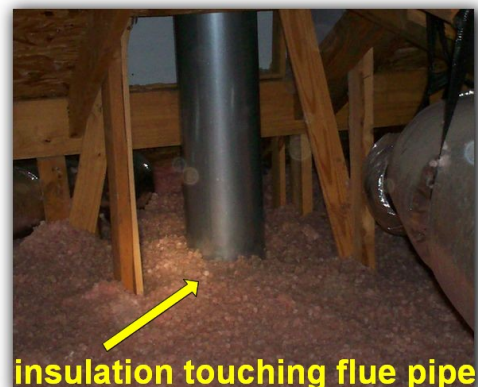
Potential Safety Issue -Attic insulation was touching the fireplace flue pipe. (see photo above right) This flue pipe should have a minimum of 2 inch clearance from combustible materials. (including attic insulation)

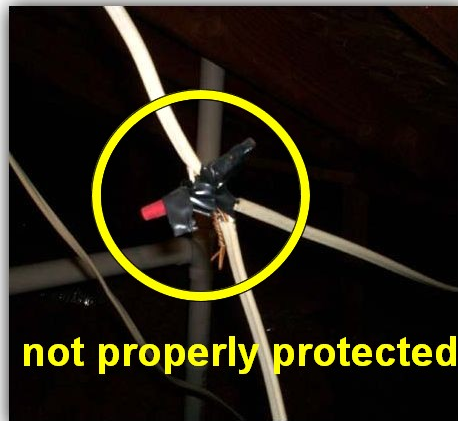
In the attic, there were electrical connections that were not properly protected. (not inside an electrical junction box.) (see photo for one example)

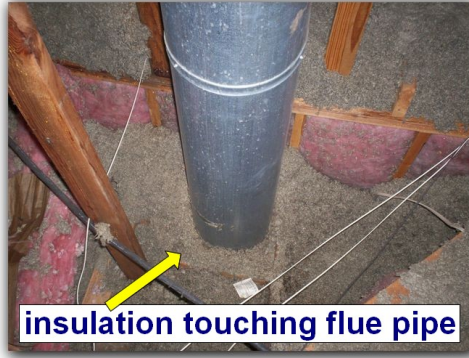
Potential Safety Issue - As viewed from the attic, the flue pipe was touching attic insulation. (see photo) This flue pipe requires a minimum of 1-inch clearance to combustible materials. (including insulation)

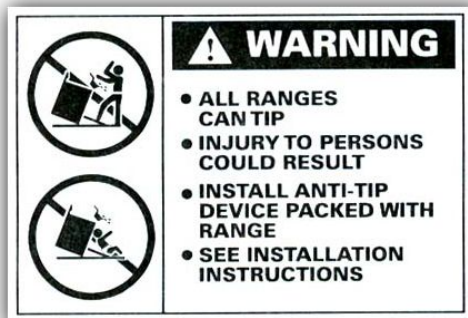
Potential Safety Issue - There was no anti-tip bracket for the oven. An anti-tip bracket is an inexpensive bracket that secures one of the oven feet to the floor so that the oven cannot be tipped forward. *Illustrations show the standard warning label for this device and it's proper placement.*
